LOW FRICTION HULL COATINGS FOR ICEBREAKERS

PHASE II, PARTS I AND II

TECHNICAL REPORT

**DEPARTMENT OF TRANSPORTATION
UNITED STATES COAST GUARD**

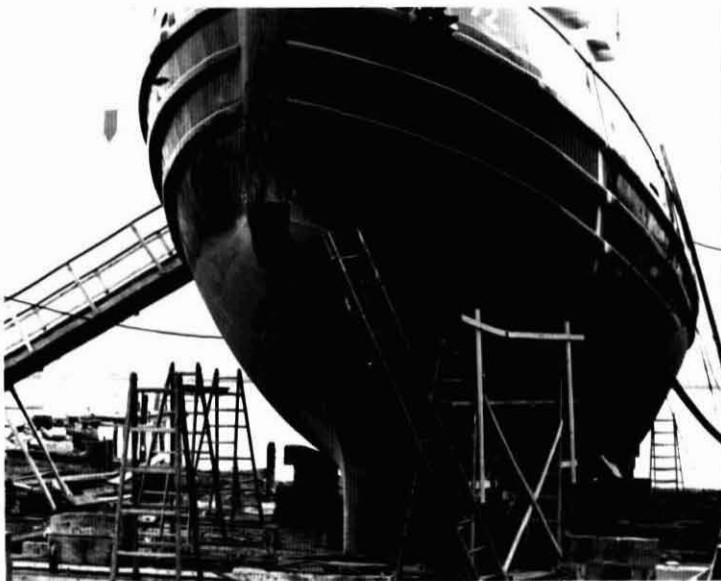
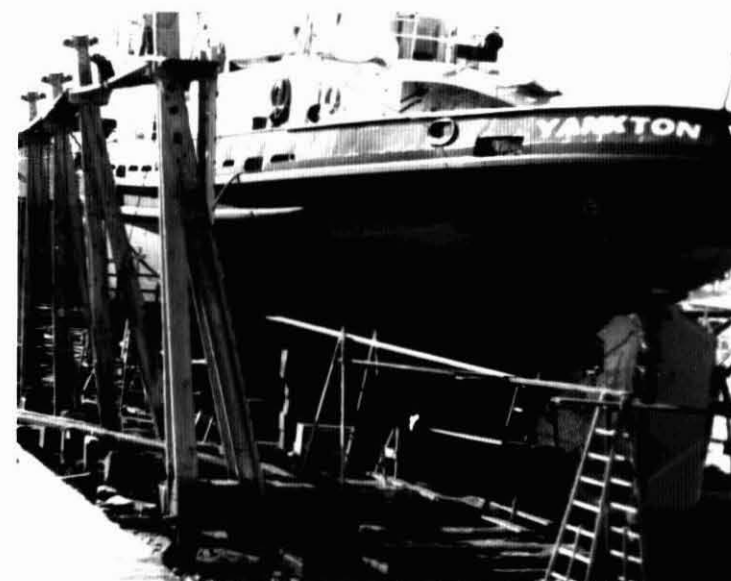
Figure II-1b Condition of the Hull of the US Cutter Yankton after Reactivation of the Primer but before Polyurethane Coating

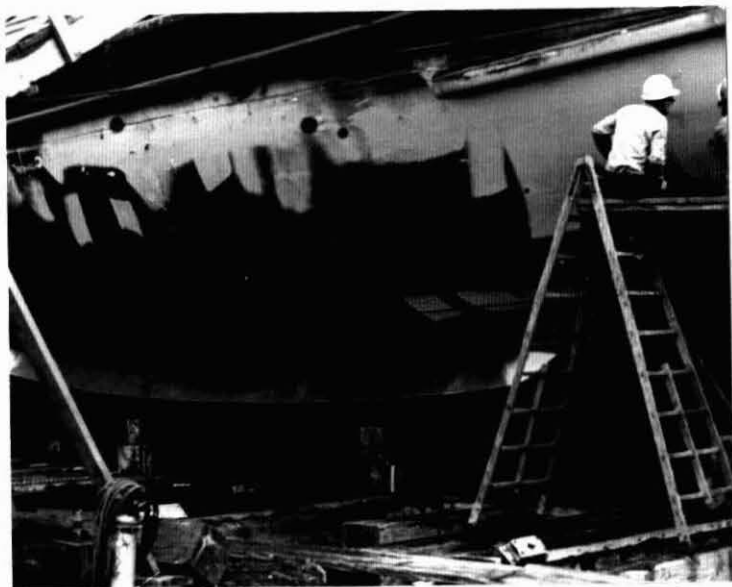
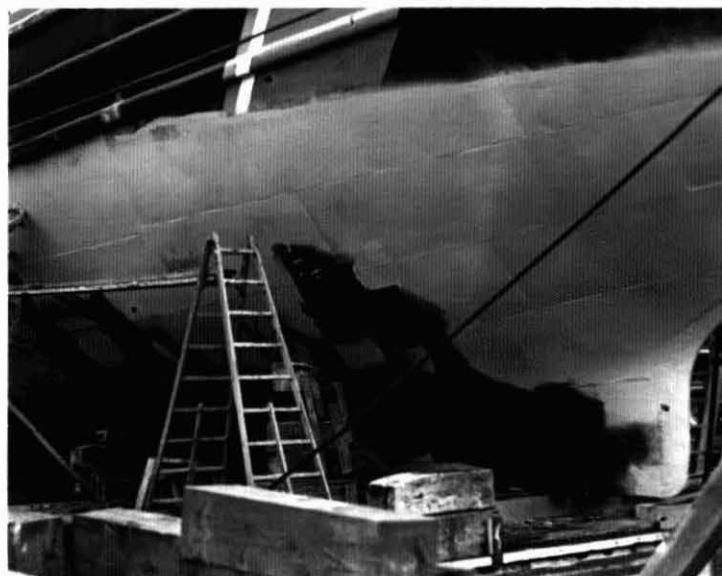
Figure II-2 Condition of the Hull of the Yankton Showing the Type of Primer Used

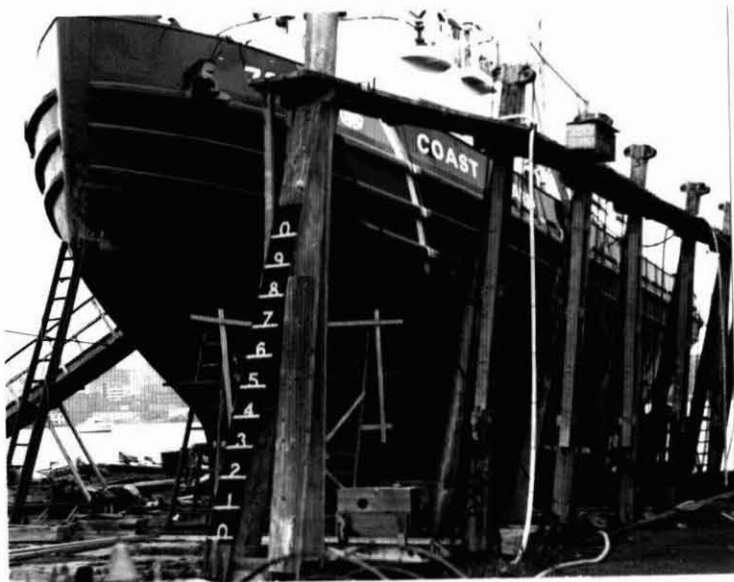
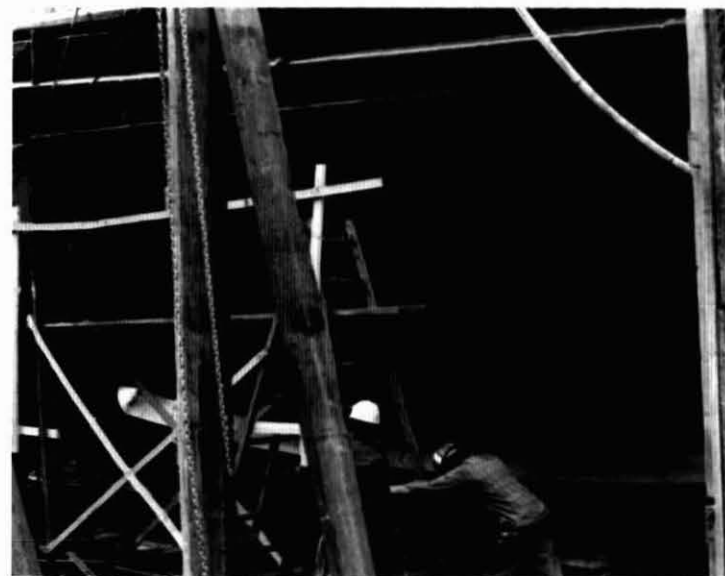
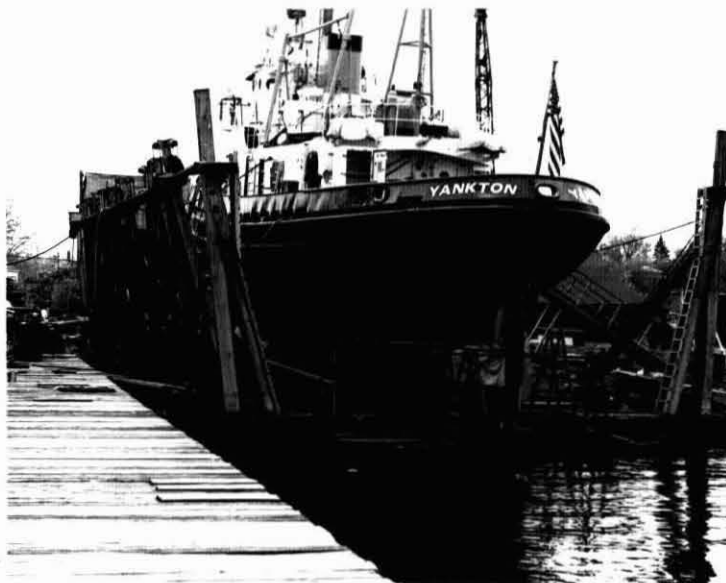
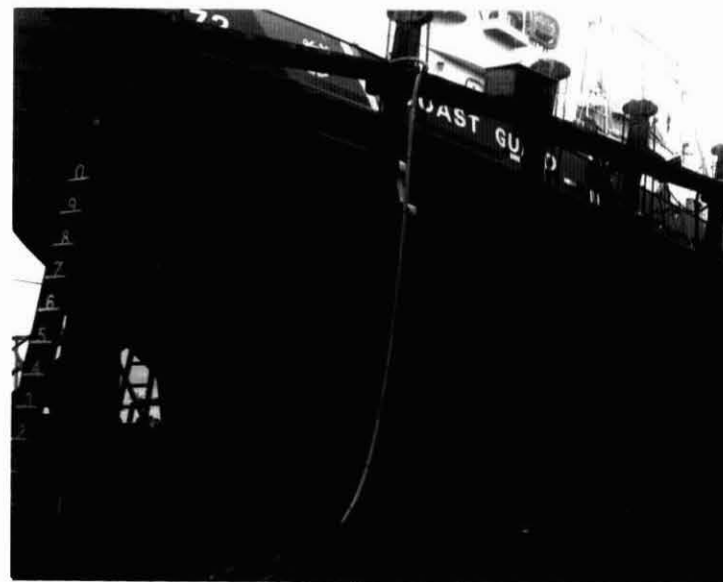
Figure II-3 Condition of the Hull of the US Cutter Yankton during Various Stages of Urethane Coating

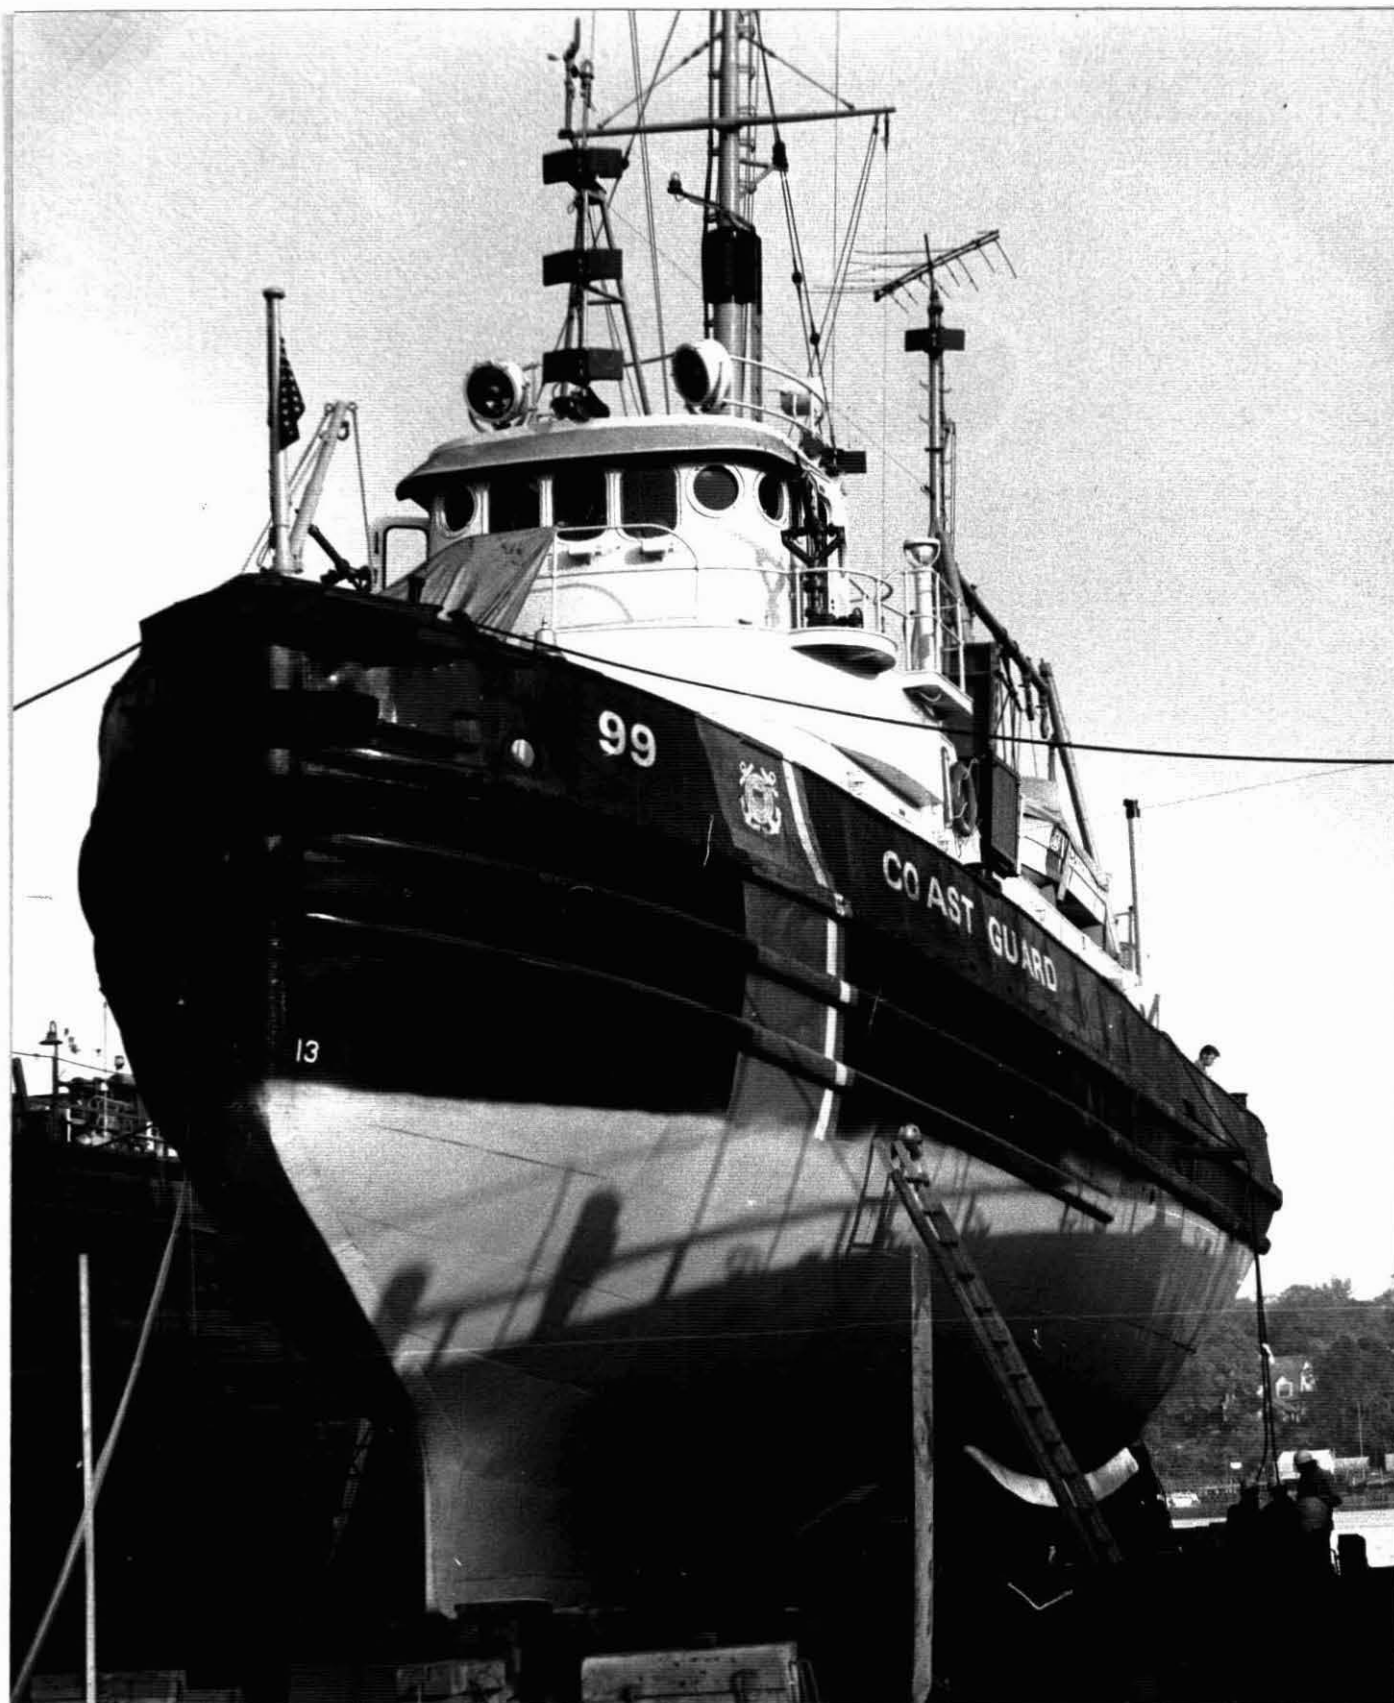
Figure II-5 Hull Appearance of the USCG Cutter Sauk after Grit Blasting

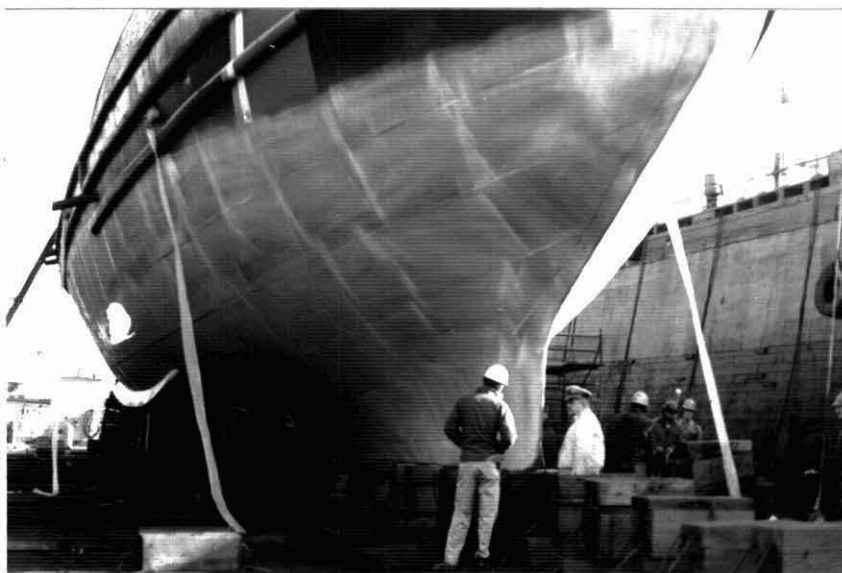
Figure II-6 Appearance of the Hull of the USCG Cutter Sauk
after Grit Blasting and Priming

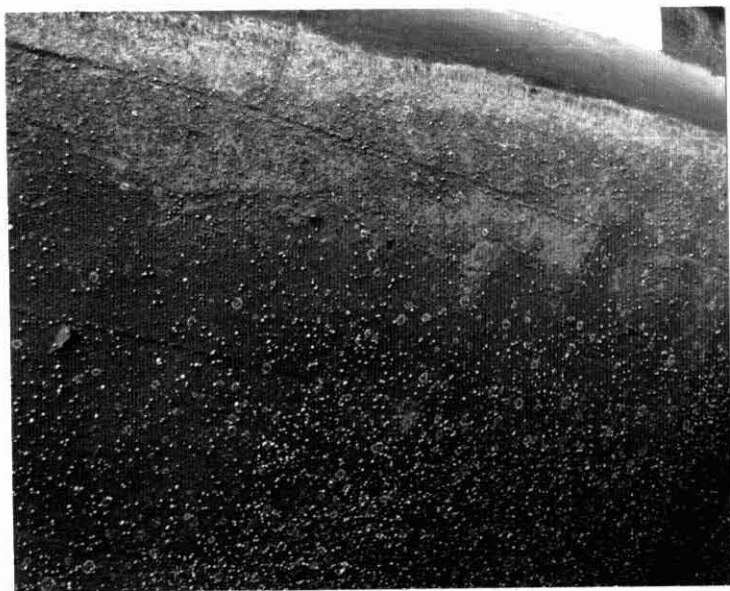
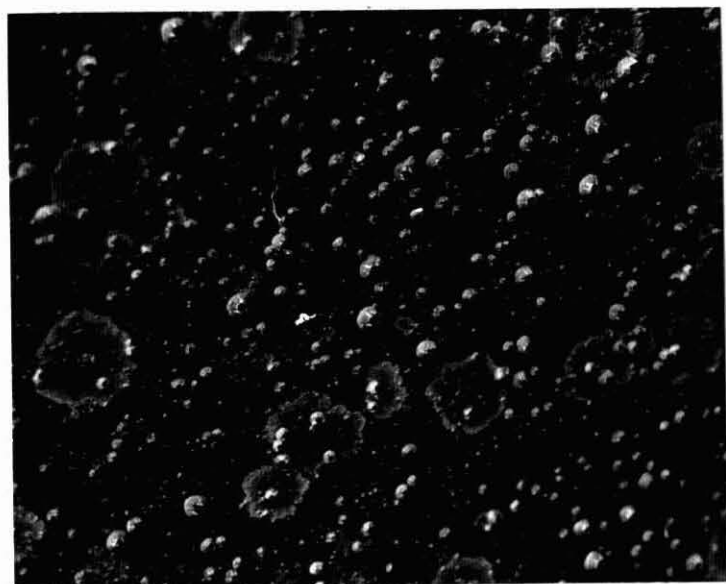
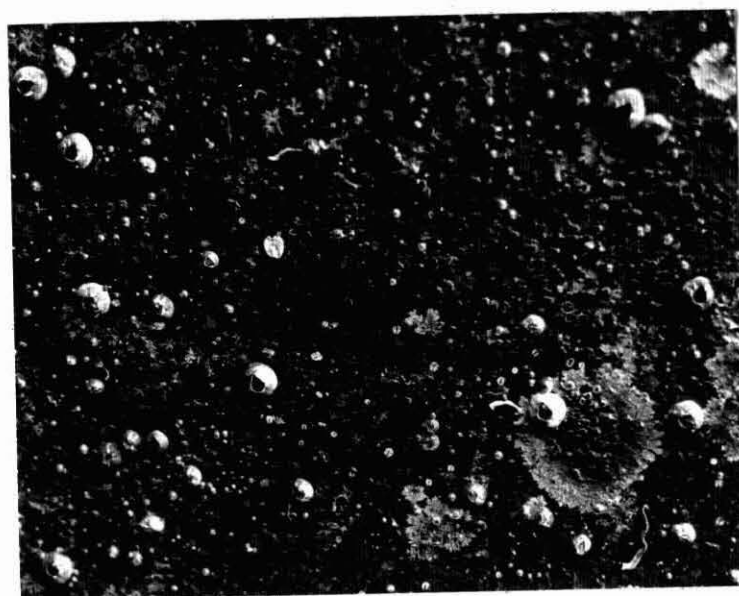
During the season the ship had logged 40.25 hours of icebreaking. It had broken both hard ice and the "pack ice" which is the small granules of ice particles compacted together. According to the information obtained on the ship, the hard solid ice appeared to present little problem with the coating.

Figure II-8 Hull Surface of the USCG Cutter Sauk after One Year of Icebreaking Service.

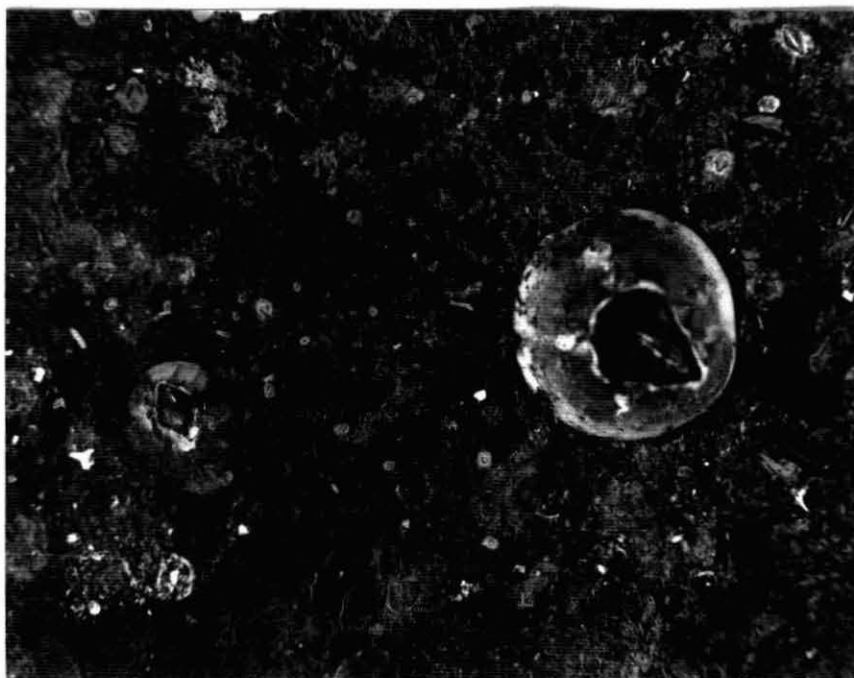
a.

One portion of the coating was removed and returned to RPI for close examination. Photomicrographs of the surface are seen in Figures II-9 and II-10. Figure II-9a shows the typical surface appearance as seen coming out of the water. Figure II-9b shows the same area with the larger barnacles removed. The white material in the center is the adhesive which the barnicle uses to attach itself to the coating. This material can be easily removed with water. Figure II-10a shows a portion of the coating as it appears on the ship (left) and a portion of the coating which was cleaned with water. Note all of the material was easily removed except for the slight discoloration where the growth had been. It should be stressed that the only fluid used for removal was water. Figure II-10b shows the same area with the large barnicle removed. Table II-6 shows a comparison of the coating properties before and after service.

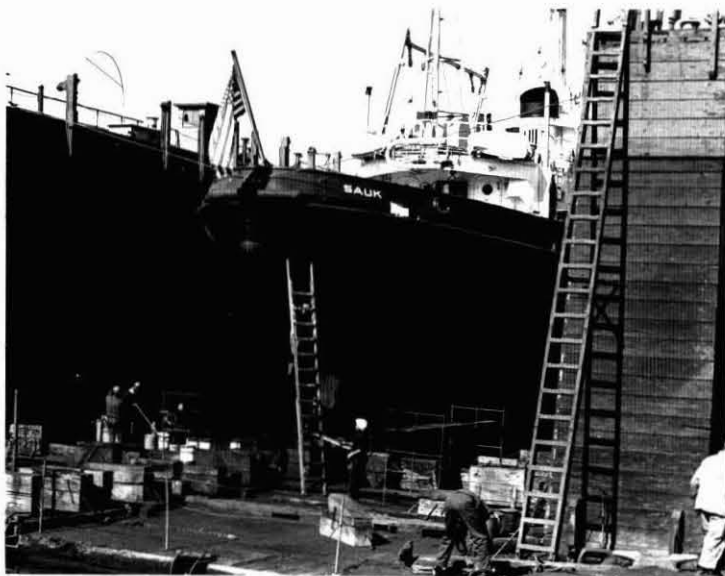
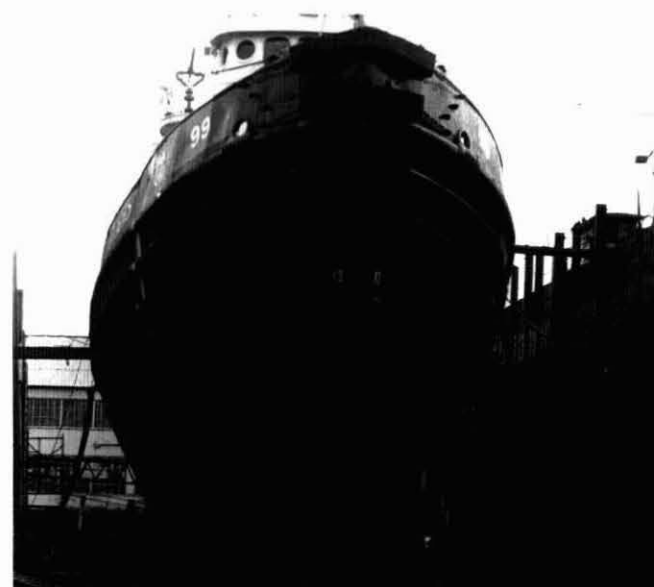
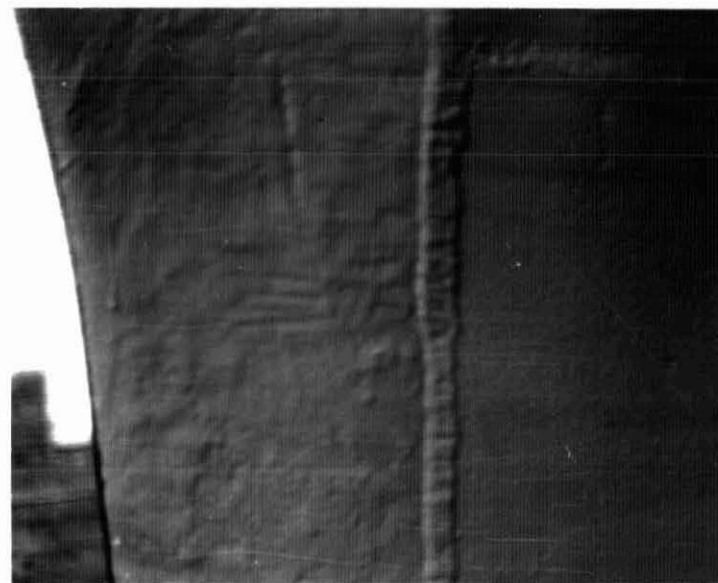
Figure II-11 Hull of the USCG Cutter Sauk after Application of a Conventional Epoxy System and a Vinyl Antifoul

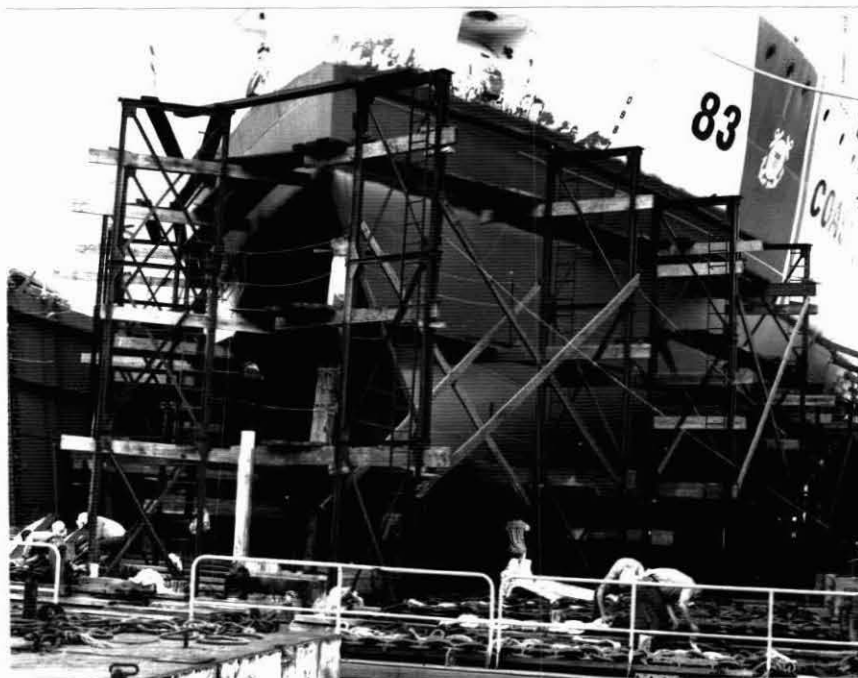
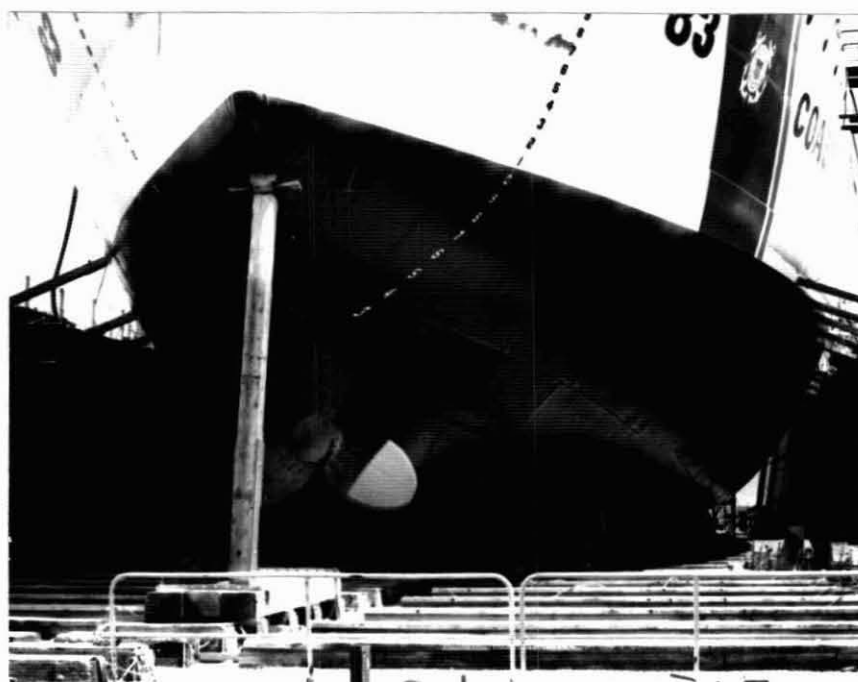
Figure II-12 Photographs of the USCG Cutter Mackinaw during and after Application of Polyurethane Coating. Port side elastomeric system, starboard side rigid urethane system

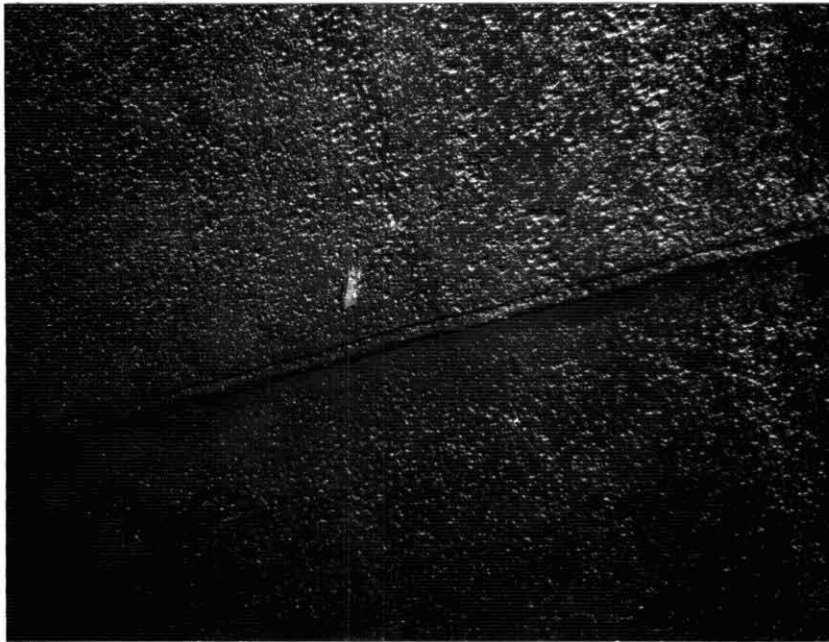
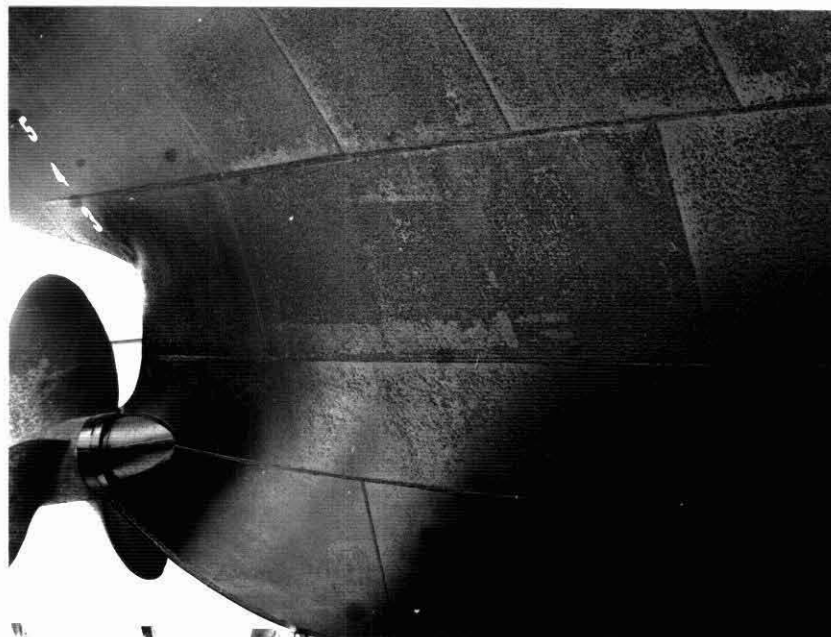
Figure II-14 Surface of Hull of Cutter Mackinaw after Application of the Elastomeric System to the Port Side. Note very heavy pitting on the hull plating.

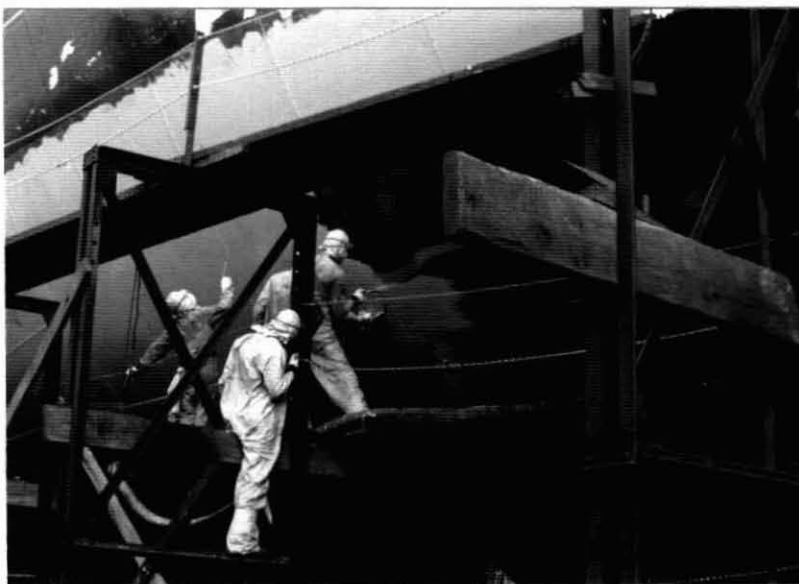
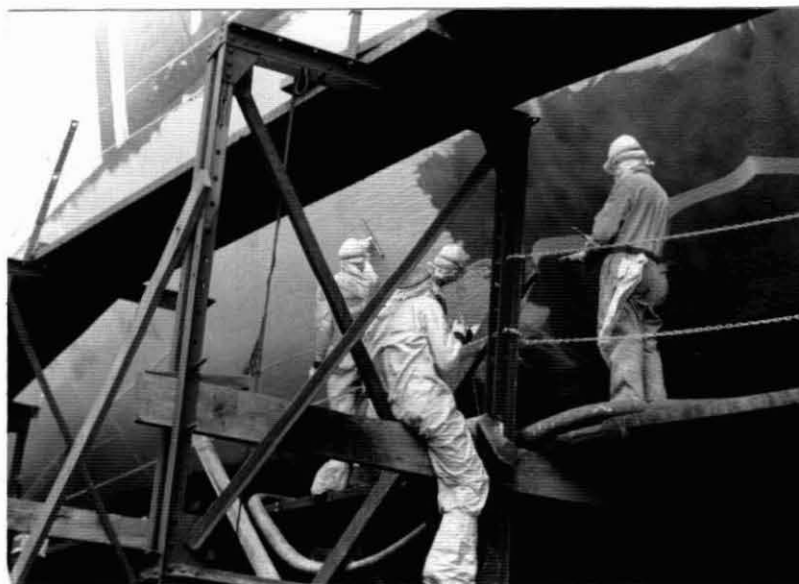
Figure II-16 Photographs Showing the Application of the First Coat of Nonsolvented Polyurethane. This coating was applied and then squeegeed down to fill the pits on the hull of the ship. Subsequent coatings were applied to build up the coating and obtain coverage.

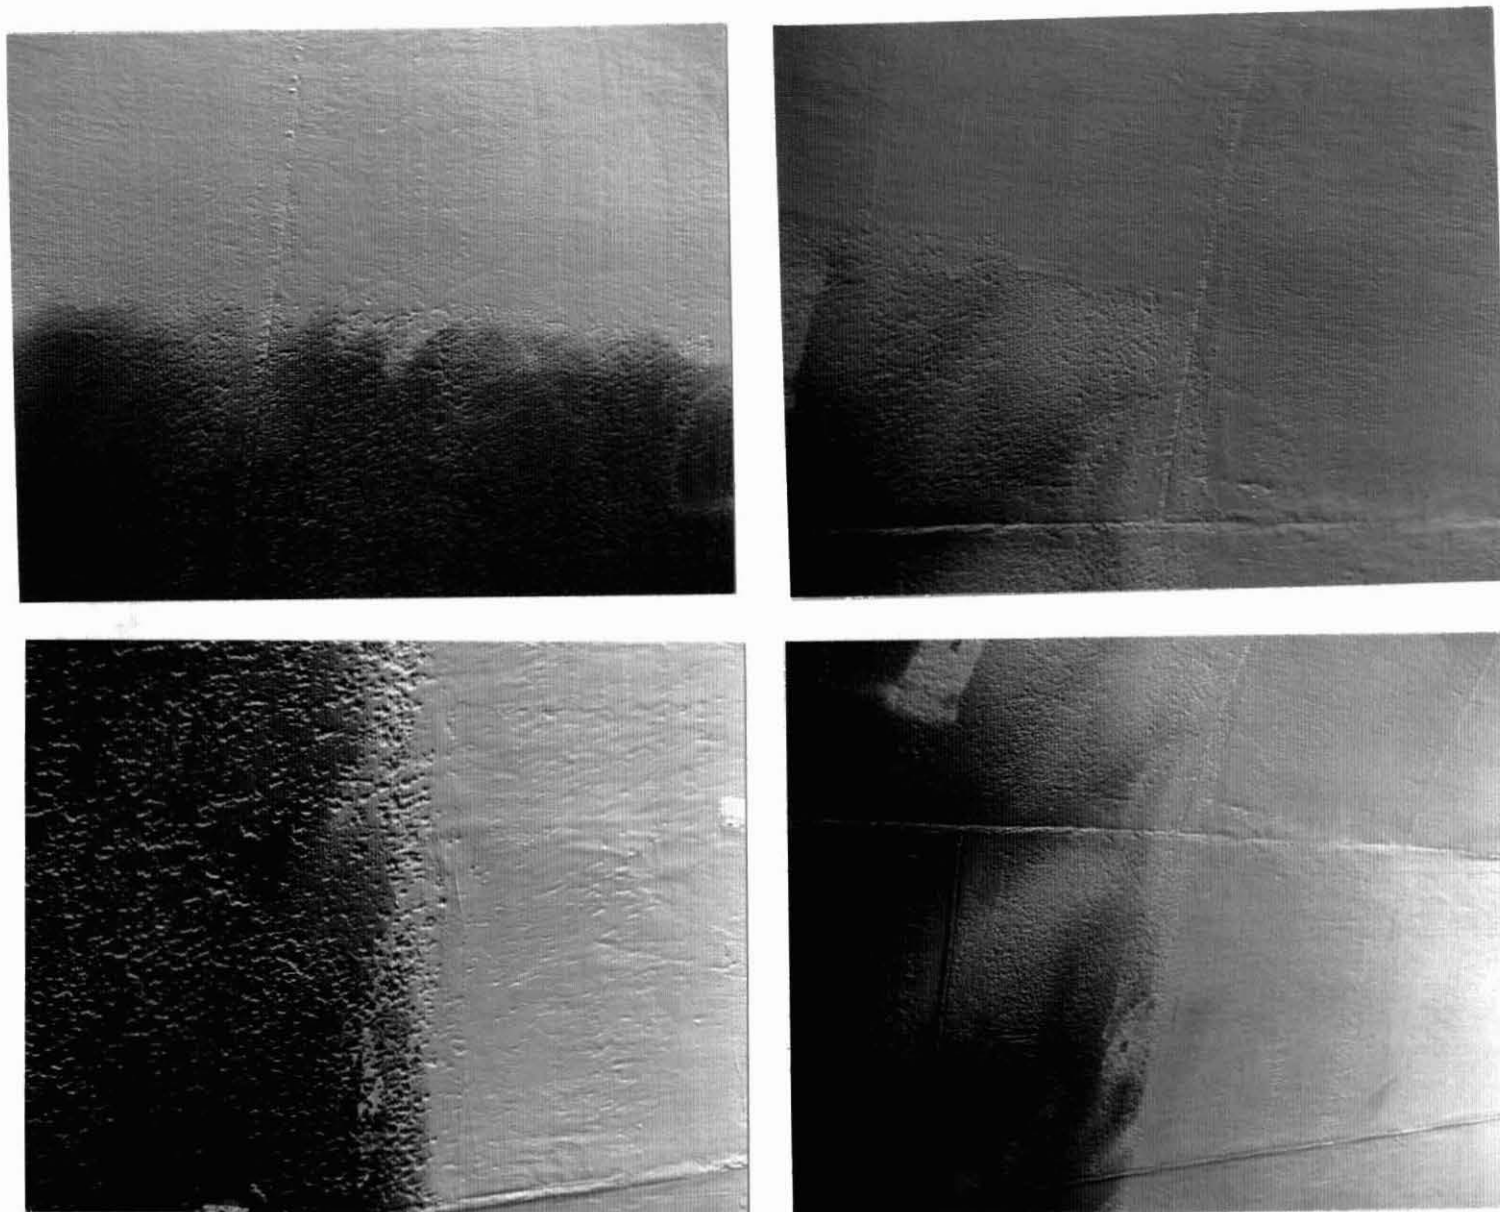
Figure II-17 Typical Hull Appearance of the USCG Cutter Mackinaw after Coating with Nonsolvented Urethane. Note the base metal showing the pits in the metal before application.

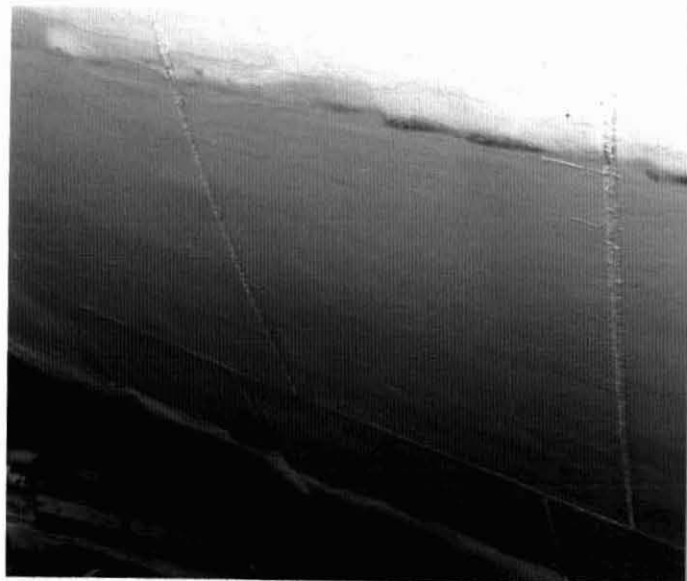
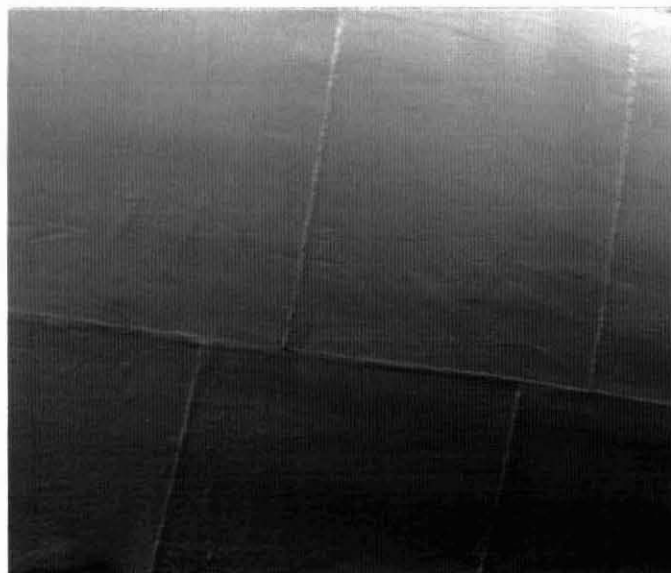
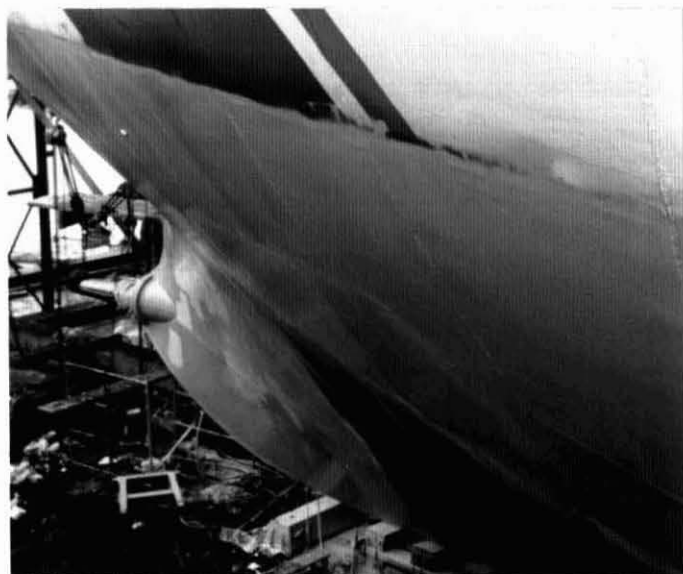
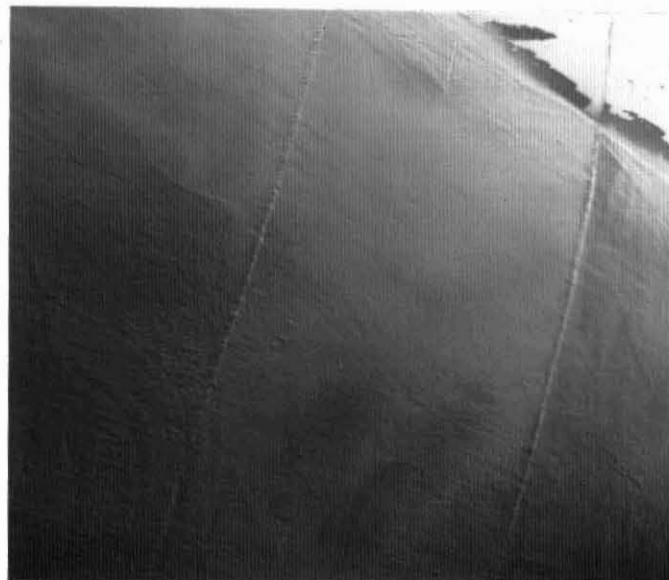
Figure II-18 Overall View of the Hull of the USCG Cutter Mackinaw after Applying the Nonsolvented Urethane

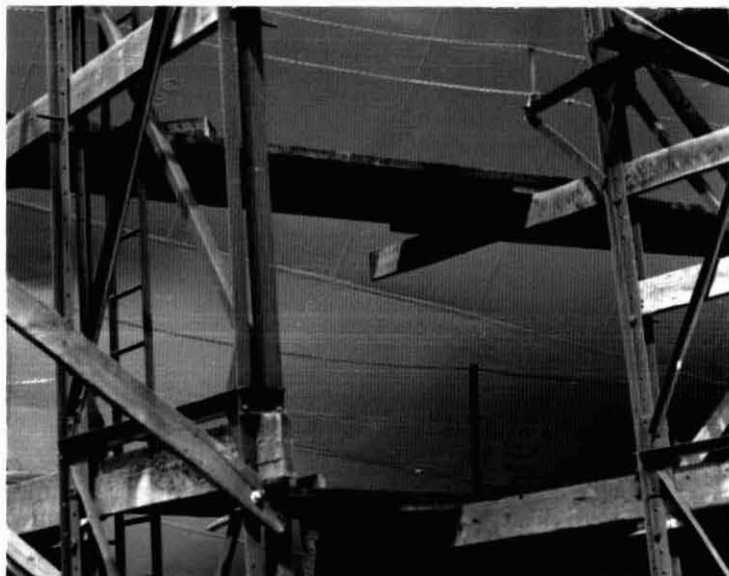
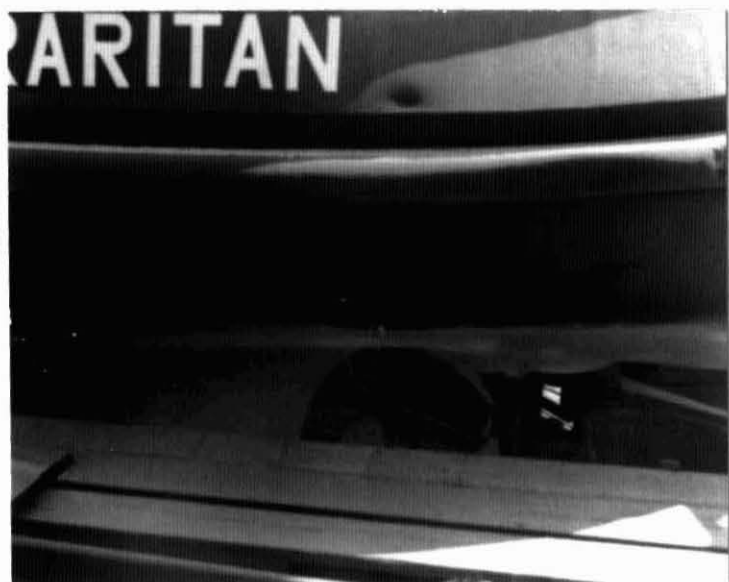
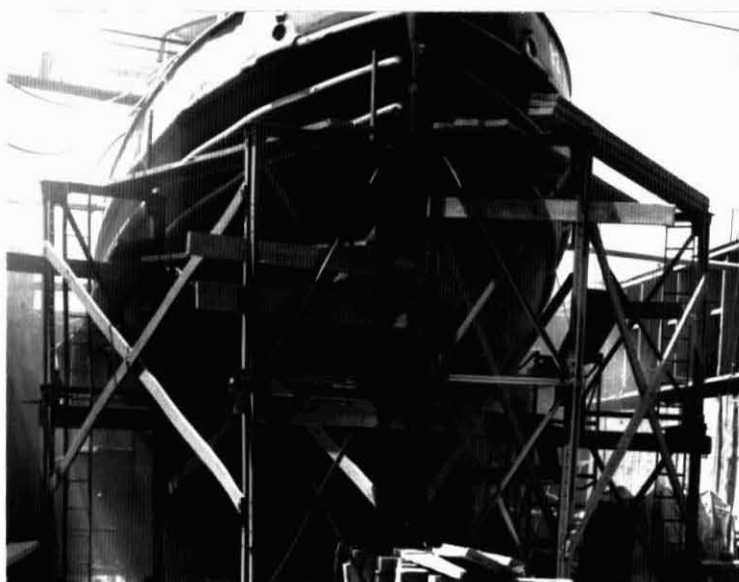
Figure II-19 Photographs of the Hull of the Cutter Raritan after Application of a Nonsolvent Polyurethane

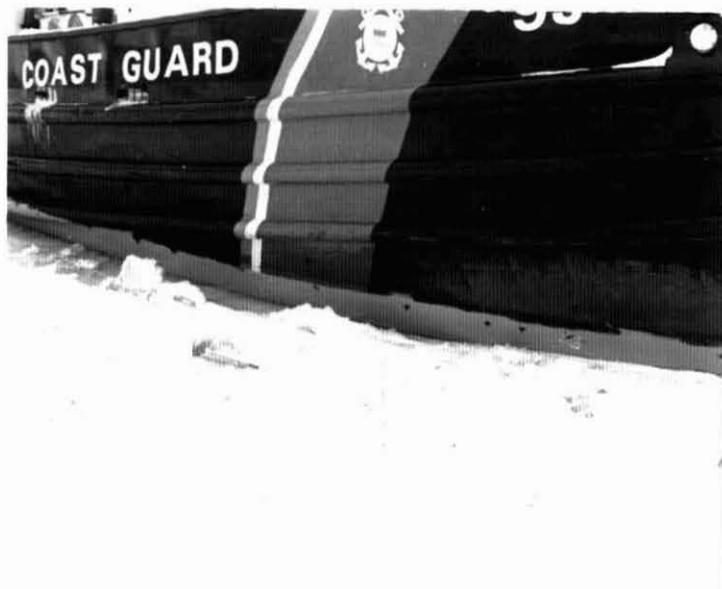
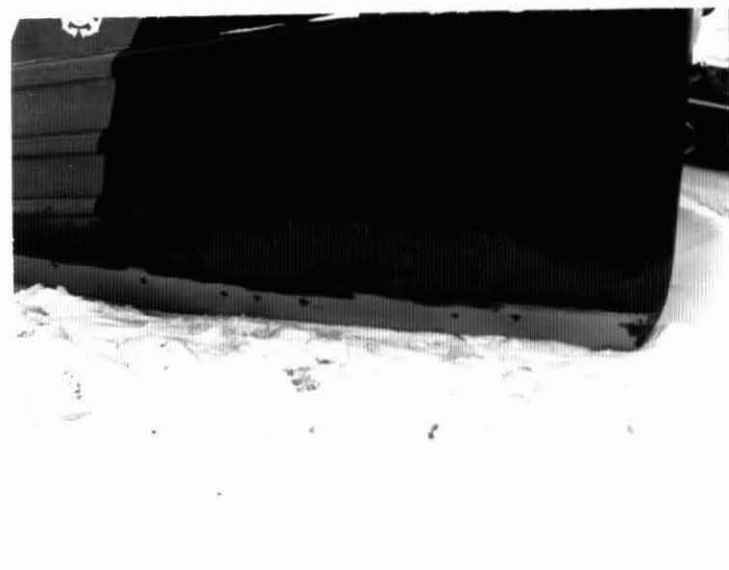
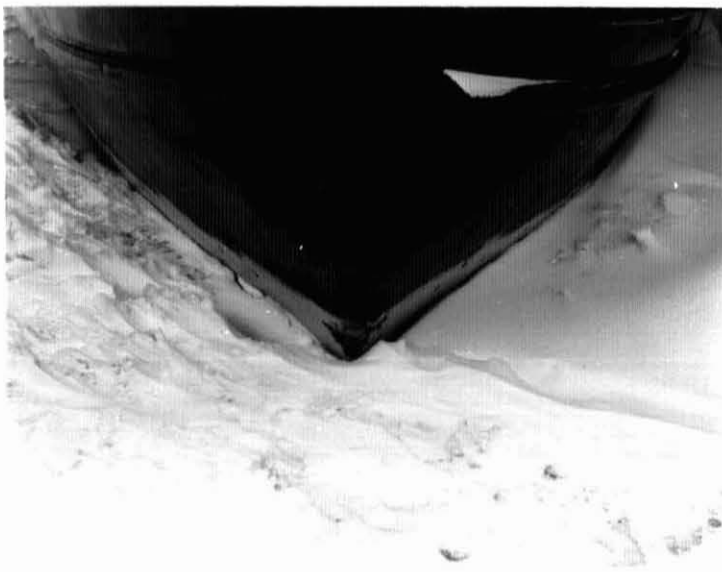
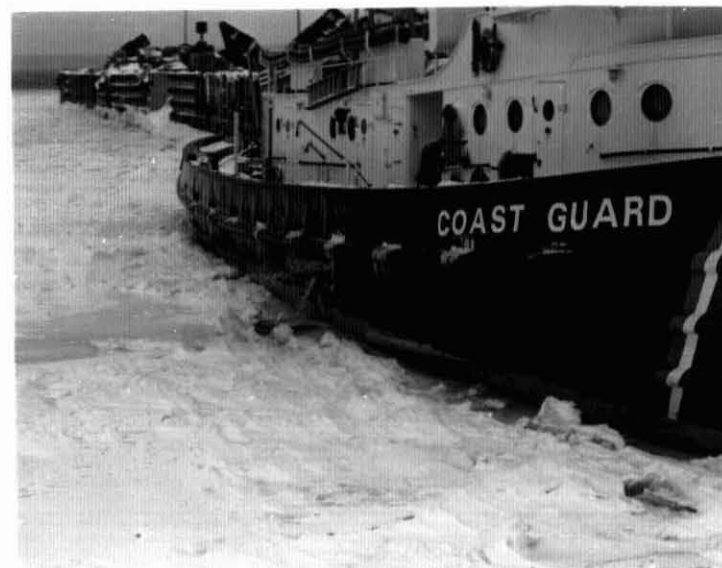
The ship had seen service assisting the Cutter Mackinaw at Sault St. Marie on the Great Lakes. At that time the coating appeared to be completely intact except for a 4" x 6" triangular shaped portion on the stern. Photographs of the ship taken during that inspection are shown in Figure II-20. The standard alkyd paint above the urethane was completely removed at the bow. Areas below the water line could not be seen because of the heavy ice, however during a period when the ship was in clear water, the hull was examined and found to show no damage as far down as could be seen.

Figure II-20 Water Line Area of the Hull of the USCG Cutter Raritan after Icebreaking Service.
Photographs taken during March 75 before the end of the icebreaking season.

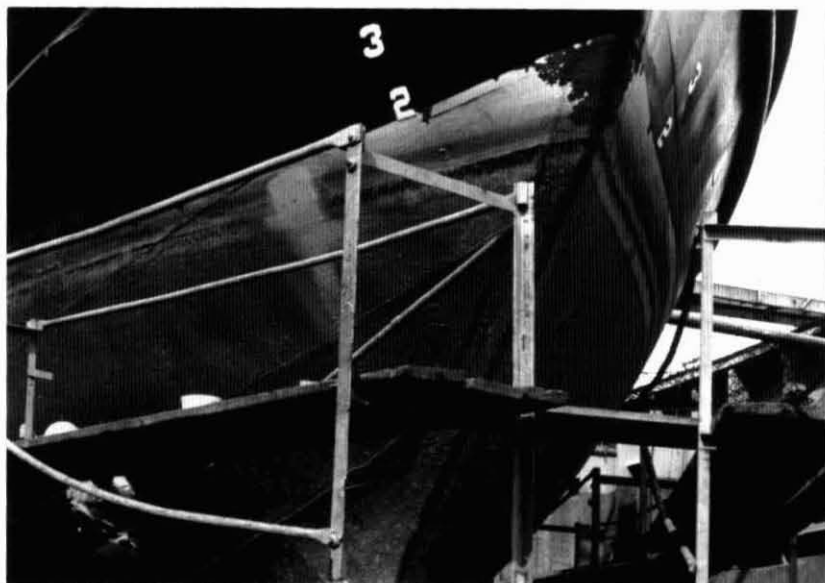
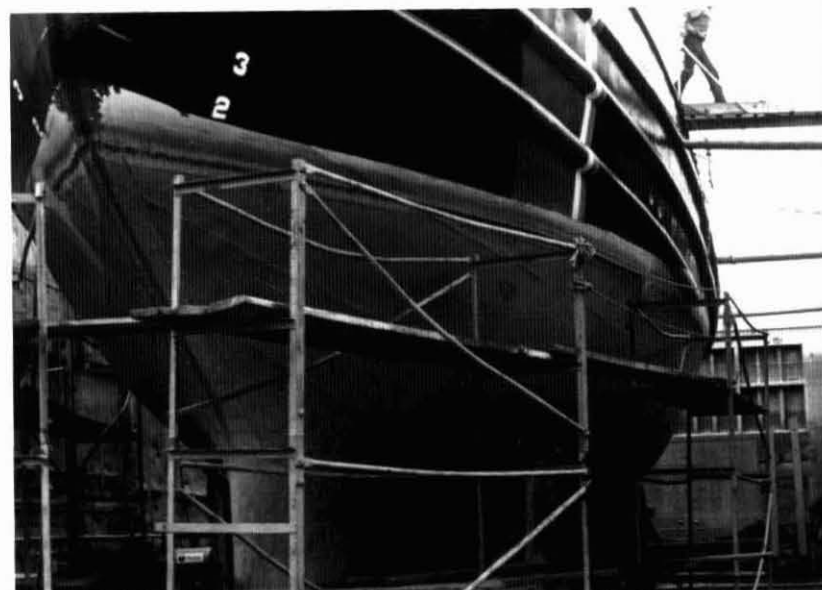
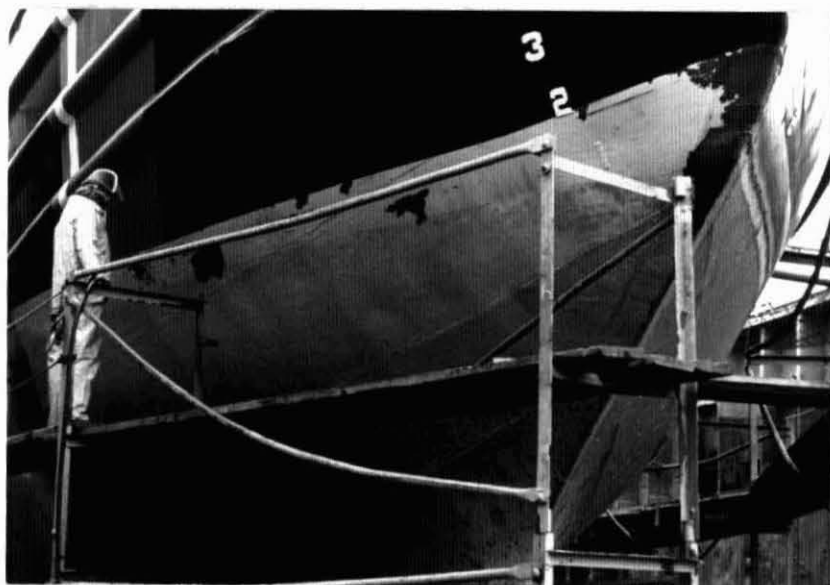
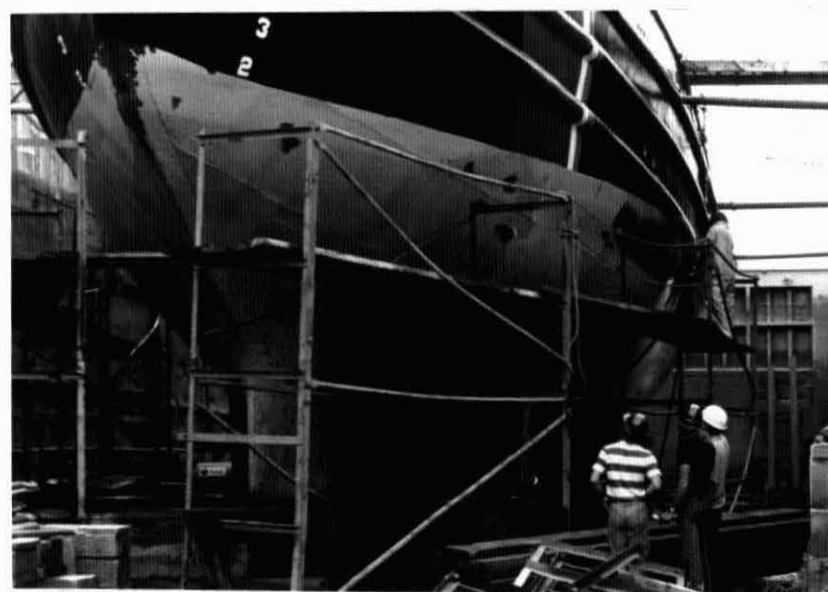
The hull was cleaned with a water jet from a hydroblast unit. The water line was completely cleaned of the grass deposits and approximately 70% of the underhull was cleaned. Photographs showing the full extent of the damage after cleaning are seen in Figure II-22.

The bulk of the damage was at the bow stem and in isolated areas near the water line. Some of the damage was said to have been caused by hitting

Figure II-22 Bow of the Cutter Raritan before (Top) and after (Lower) Cleaning by Hydroblasting

foreign objects in the water. According to ships captain and crew, at least one of the chipped areas on the port side was said to have been caused by striking a foreign object in the water during icebreaking.

All areas at the waterline and at the bow where damage or mismetering had occurred were repaired while in dry dock. The repair was accomplished by hand mixing the coating material and trowelling it on the surface after being cleaned, grit blasted and primed. In addition a three-foot section above the water line at the bow and tapering back to the water line was coated. This protects the upper bow against ice which slides against it, after it is broken and forced under the hull. The additional coating will also eliminate a coating edge in the bow area where the most severe damage occurs. The condition of the hull after grit blasting is seen in Figure II-23.
